# FRACTURE TOUGHNESS AND BRITTLE FAILURE: A PRESSURE VESSEL CASE STUDY

Authors: John Puryear , Guillermo Ramirez,  
Clint Botard, and Kollin Kenady

Published online 00 Month 2017 in Wiley Online Library (wileyonlinelibrary.com). DOI 10.1002/prs.11955

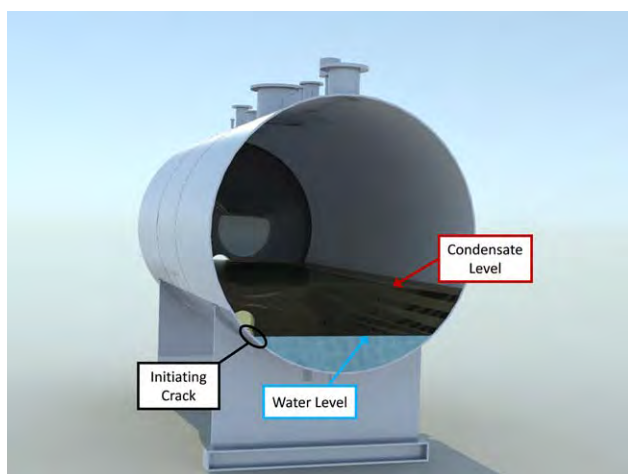
A discontinuity in the interior surface of the head, near the weld at about the 7 o'clock position (Figure 1), either existed when the separator was delivered or occurred during operation of the separator. Laboratory findings support the theory that sulfide stress corrosion cracking began at the discontinuity and progressed slowly over years. This corrosion mechanism is consistent with the sour service conditions and age of the separator.

**Figure 1.** Location of crack initiation. [Color figure can be viewed at [wileyonlinelibrary.com](http://wileyonlinelibrary.com)]

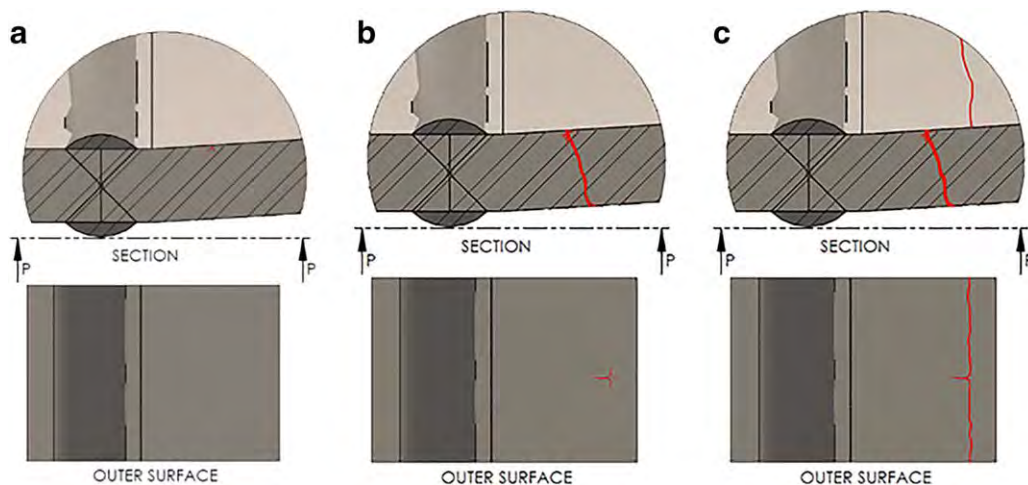
The initial discontinuity and the small, tightly closed cracks were not detected by standard inspection methods before, or after, the accident. Only subsequent laboratory examination was able to identify the cracks. Standard inspection methods before and after the accident did identify thinning from general corrosion; nevertheless, the thickness of the head was above the retirement thickness. The cracking progressed through the thickness and caused a small release that was detected by gas detectors. Within minutes, the crack grew to the critical length that caused the complete circumferential failure of the head. The progress of the crack is illustrated in Figure 2.

**Figure 2.** Crack propagation from inner to outer surface. [Color figure can be viewed at [wileyonlinelibrary.com](http://wileyonlinelibrary.com)]

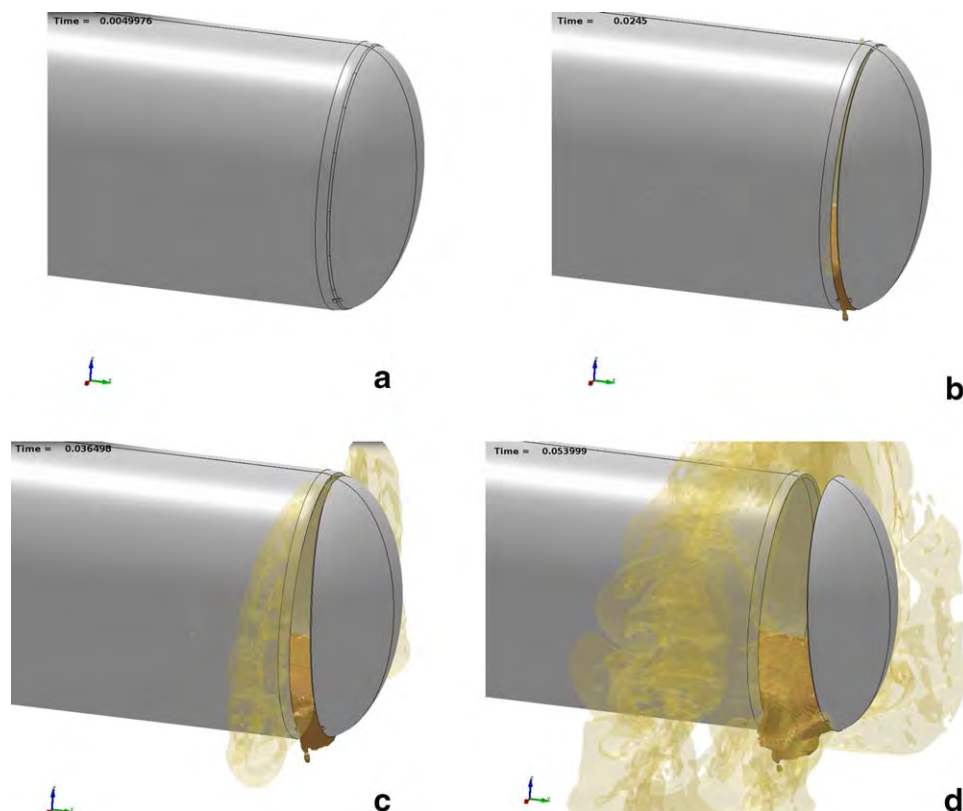
The failure sequence described above was developed and verified using onsite personnel interviews, line operation data, postincident evidence gathering, gas detector data, analytical calculations, numerical analysis, and laboratory examination and analysis. Output from a simulation of the failure sequence is shown in Figure 3. That simulation was performed using the Arbitrary-Lagrangian Eulerian method in LS-DYNA, a multi-physics solver developed by Livermore Software Technology Corporation.

**Figure 3.** Separator failure sequence. [Color figure can be viewed at [wileyonlinelibrary.com](http://wileyonlinelibrary.com)]

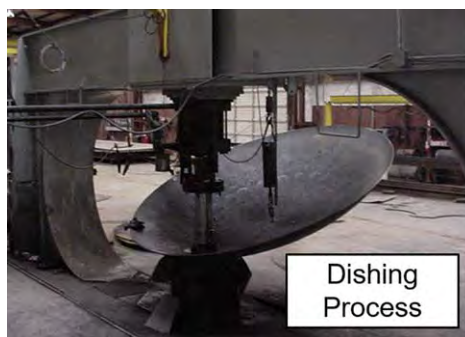
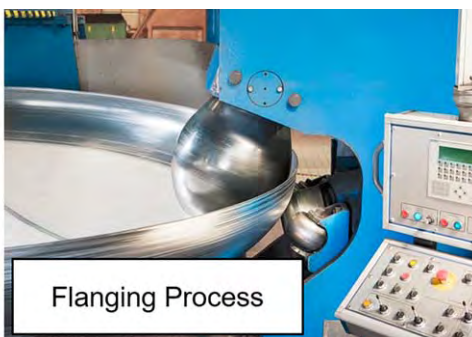
The head manufacturing process further increased this vulnerability to brittle failure. The cold working during dishing and flanging (Figure 5) introduced high residual stresses, increased the ultimate strength of the steel, decreased its ductility, and reduced its fracture toughness. These observations came from laboratory tests comparing mechanical properties at the apex of the head to properties at the knuckle.

**Figure 5.** Head dishing and flanging process (image courtesy of Slawinski, [www.slawinski.de](http://www.slawinski.de)). [Color figure can be viewed at [wileyonlinelibrary.com](http://wileyonlinelibrary.com)]

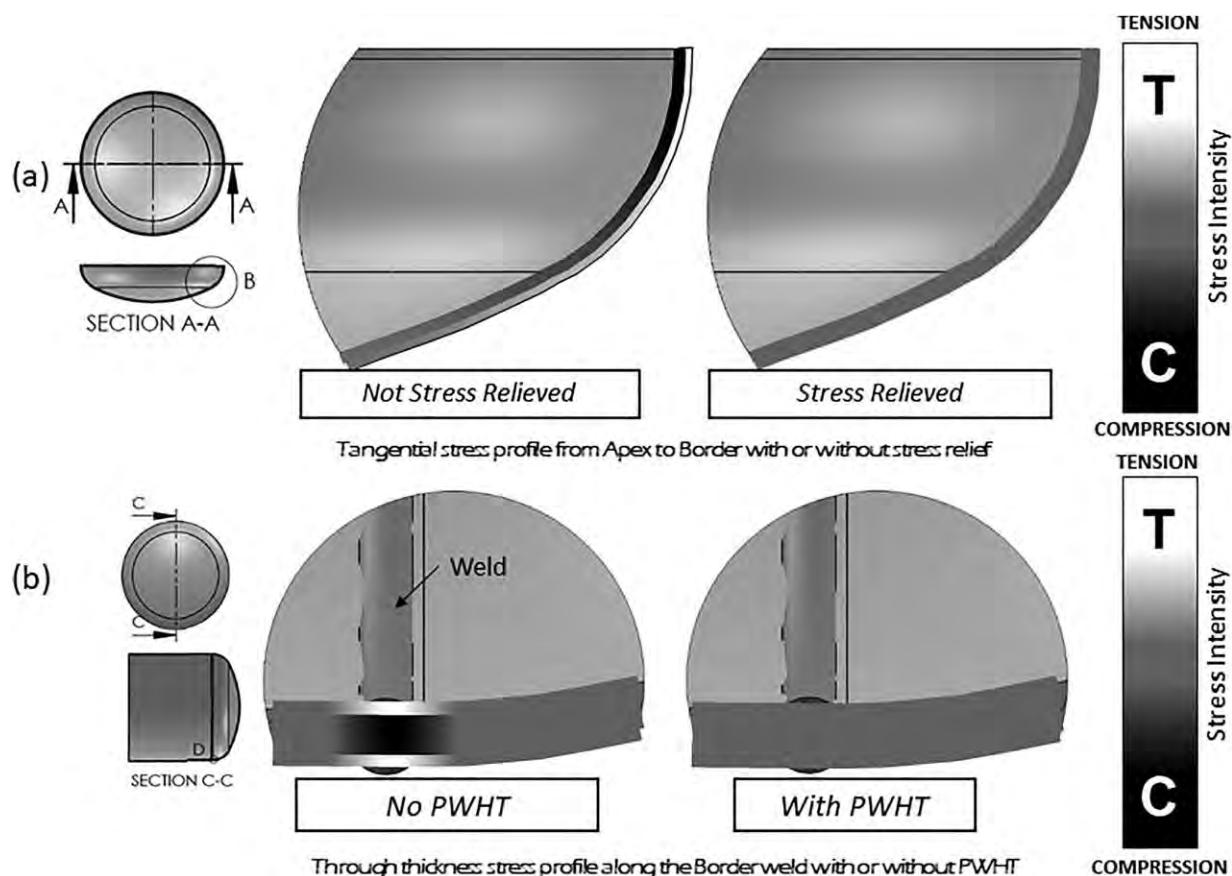
The residual stresses introduced during manufacture remained because of a lack of heat treatment and/or insufficient post-weld heat treatment. These processes are shown in Figures 6 and 7. Residual stresses in the vicinity of the failure were further increased by welding the head to the vessel shell. The reduction in residual stress concentrations due to stress relief and post-weld heat treatment is illustrated in Figure 8. In the figure, "T" refers to tensile stress and "C" refers to compressive stress.

**Figure 8.** Reduction in residual stress concentration due to (a) stress relief and (b) post-weld heat treatment.
