# FRACTURE TOUGHNESS AND BRITTLE FAILURE: A PRESSURE VESSEL CASE STUDY

Authors: John Puryear , Guillermo Ramirez,  
Clint Botard, and Kollin Kenady

Published online 00 Month 2017 in Wiley Online Library (wileyonlinelibrary.com). DOI 10.1002/prs.11955

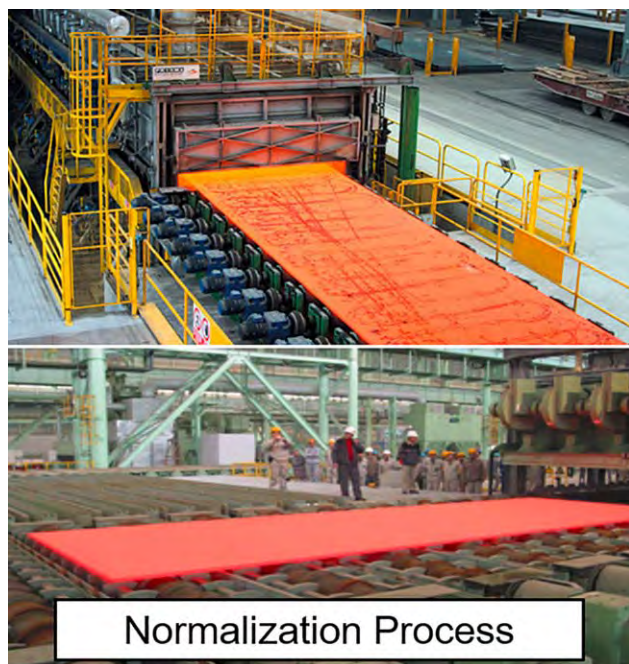
**Figure 4.** Normalization process (image courtesy of Prisma Impianti, [www.prismagroup.it](http://www.prismagroup.it) and Wesman Group, [www.wesman.com](http://www.wesman.com)). [Color figure can be viewed at [wileyonlinelibrary.com](http://wileyonlinelibrary.com)]

Laboratory analyses performed following the incident revealed the effects of the manufacturing process on the separator's mechanical properties with the results showing that the head metal was not normalized steel. Normalization is a heat treatment that produces a more uniform microstructure in the steel; the process is illustrated in Figure 4. In terms of mechanical properties, the mill plate used to manufacture the heads had relatively low fracture toughness and was thus vulnerable to brittle failure. In practical terms, lack of normalization meant that the heads did not have the heat treatment that would reduce the potential for crack growth and propagation.

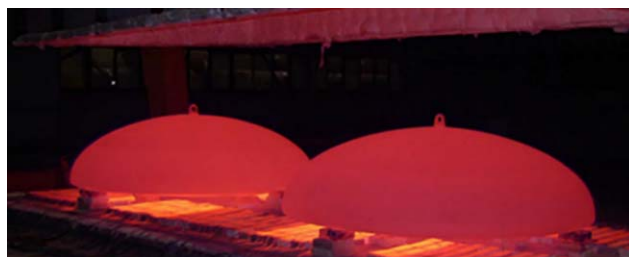
**Figure 6.** Stress relief process (image courtesy of Myungjin Heat-Treatment, Inc., [www.mhti.co.kr](http://www.mhti.co.kr)). [Color figure can be viewed at [wileyonlinelibrary.com](http://wileyonlinelibrary.com)]

The residual stresses introduced during manufacture remained because of a lack of heat treatment and/or insufficient post-weld heat treatment. These processes are shown in Figures 6 and 7. Residual stresses in the vicinity of the failure were further increased by welding the head to the vessel shell. The reduction in residual stress concentrations due to stress relief and post-weld heat treatment is illustrated in Figure 8. In the figure, "T" refers to tensile stress and "C" refers to compressive stress.

when a through-thickness crack is produced. Stress relieving allows a significant reduction in residual stresses that occur from the cold-forming processes. However, the BPVC accepted at the time of the separator's manufacture did not require that the metal used in forming the sour service separator heads be a normalized steel or that stress-relief after cold forming be applied to the head.
